A Preliminary Summary Of The September 11, 2012 Las Vegas Valley Heavy Rain And Flash Flood Event

Chris Stachelski

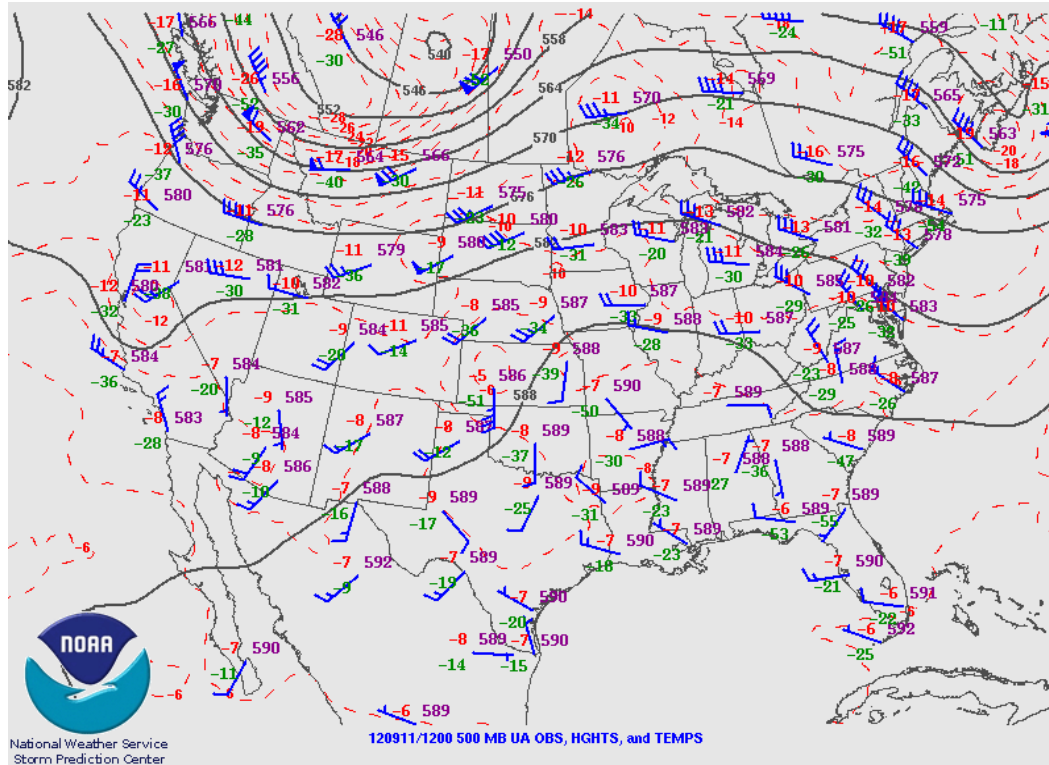
Upper air charts showing the observed values at 500 mb at 12Z on September 11, 2012 (top) and 00Z on September 12, 2012 (bottom). Blue wind barbs can be noted on both maps while solid black lines indicate height lines. Maps courtesy Storm Prediction Center.

An area of low pressure was noted over central California in the mid and upper levels at 12Z on September 11th. Ahead of this low, exceptionally moist and unstable air existed over the Mojave Desert and southern Great Basin. The 12Z radiosonde launched from Las Vegas measured a precipitable water value of 1.37 inches and an 850 mb dewpoint of 11 degrees Celsius indicative of an extremely moist air mass. Precipitable water values over an inch and 850 dewpoints at or above 8 degrees Celsius are usually indicative of an atmosphere conducive to flash flooding in the Mojave Desert based on local rules of thumb. The combination of the enhanced lift from the low and a very moist atmosphere produced a set-up favorable for thunderstorms producing heavy rain. The low moved across southern Nevada between 19Z and 23Z with showers and thunderstorms ahead of it.

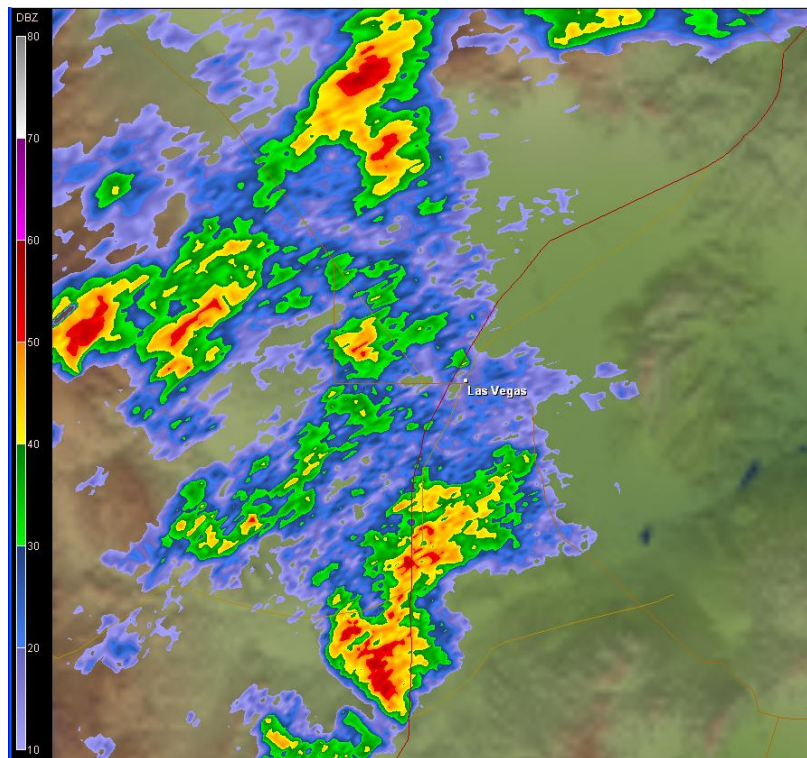
KESX 0.5 degree radar reflectivity at 2017Z on September 11th as thunderstorms started to move east across the valley.

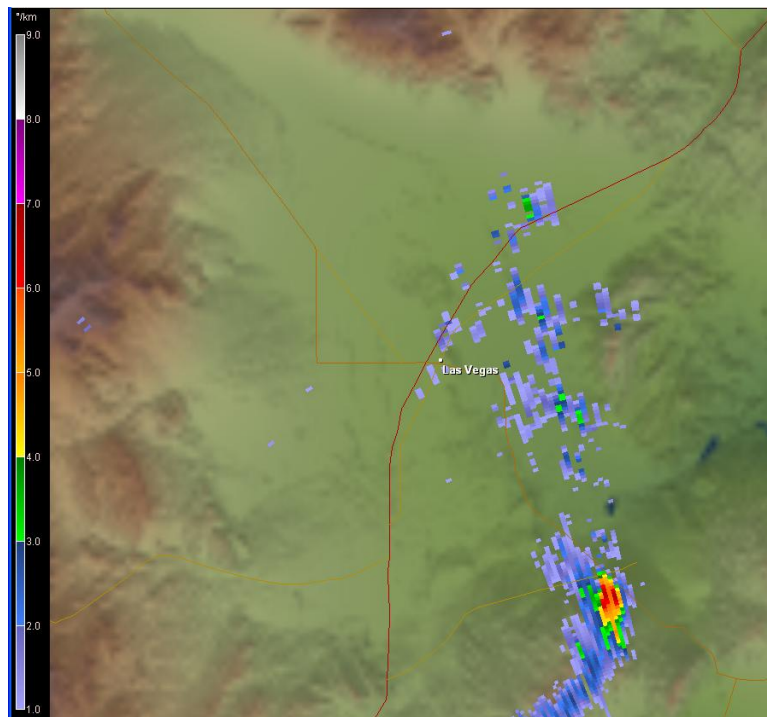
KDP values from the Las Vegas weather radar at 21:01Z on September 11th. Note the area of bright colors over the southeast part of Las Vegas where values approached 6 deg/km. Values below 1.0 deg/km are not shown.

Cross sections of radar showed in general that the greatest reflectivity values were mainly centered at 5,000 feet even in cases where thunderstorm tops built to nearly 30,000 feet. This resulted in an environment where warm rain processes dominated and heavy rain fell from thunderstorms. The Specific Differential Phase (KDP) on the Las Vegas WSR-88D showed values at or above 1 deg/km in several areas across the central and southeast part of the Las Vegas Valley, especially over southeast Henderson where KDP values exceeded 6 deg/km in a small area. With KDP, higher values indicate a greater possibility that heavy rain is falling over a given area.

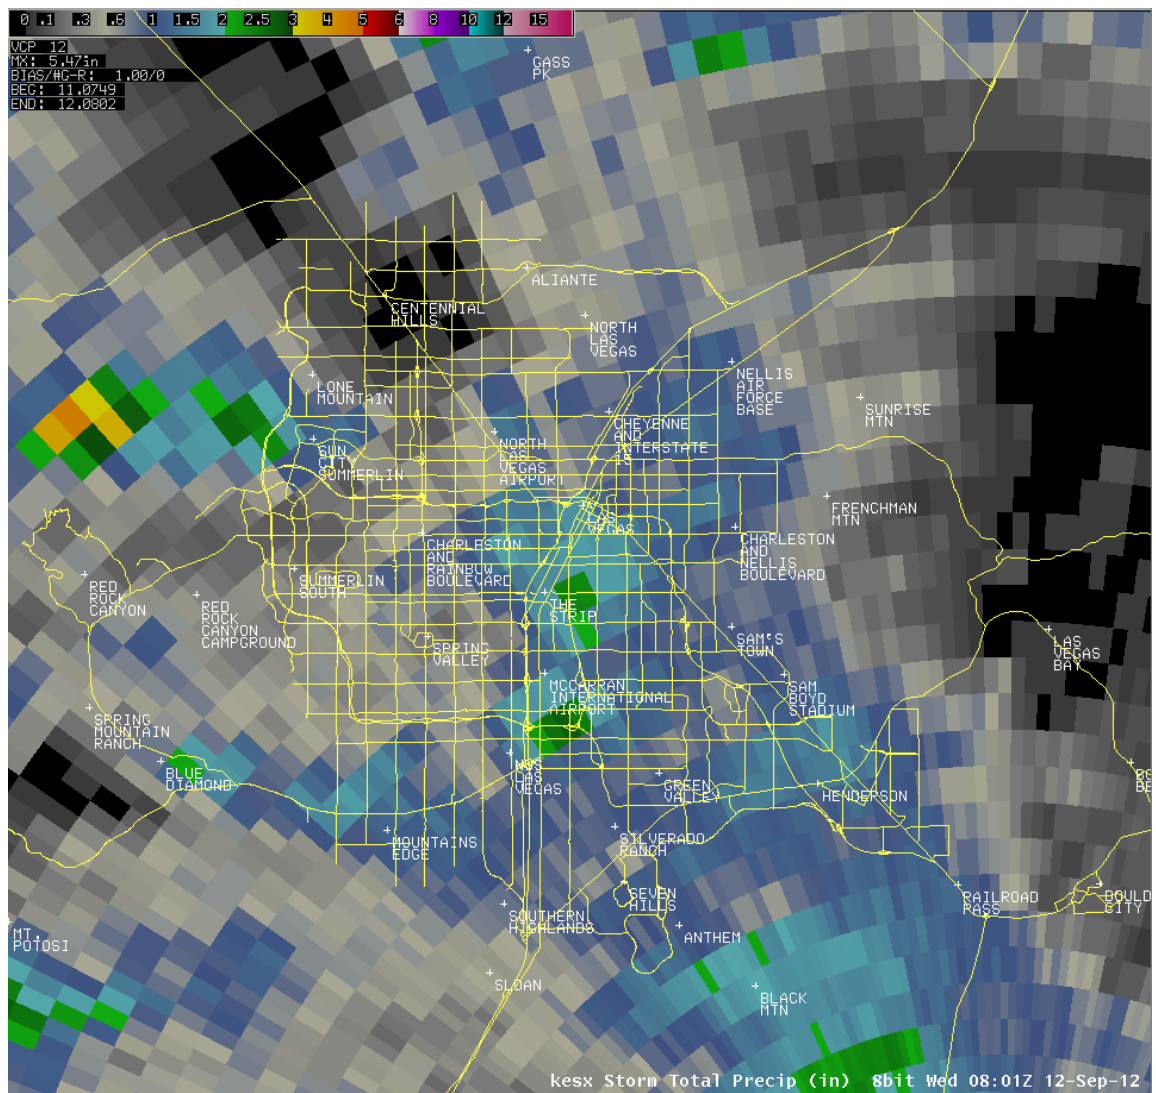
KESX legacy storm total precipitation estimates across the Las Vegas Valley for the September 11th event.

Storm total radar estimates from the Las Vegas WSR-88D radar were in fairly good agreement from both the legacy estimation and the new dual polarization estimates. The radar was switched by the staff at the National Weather Service in Las Vegas into a tropical Z-R relationship for this event due to the rather moist air mass in place across the area. Comparing totals from both the legacy and dual polarization estimates to ground measurements, both seemed to correlate estimate values very close to what was actually measured.

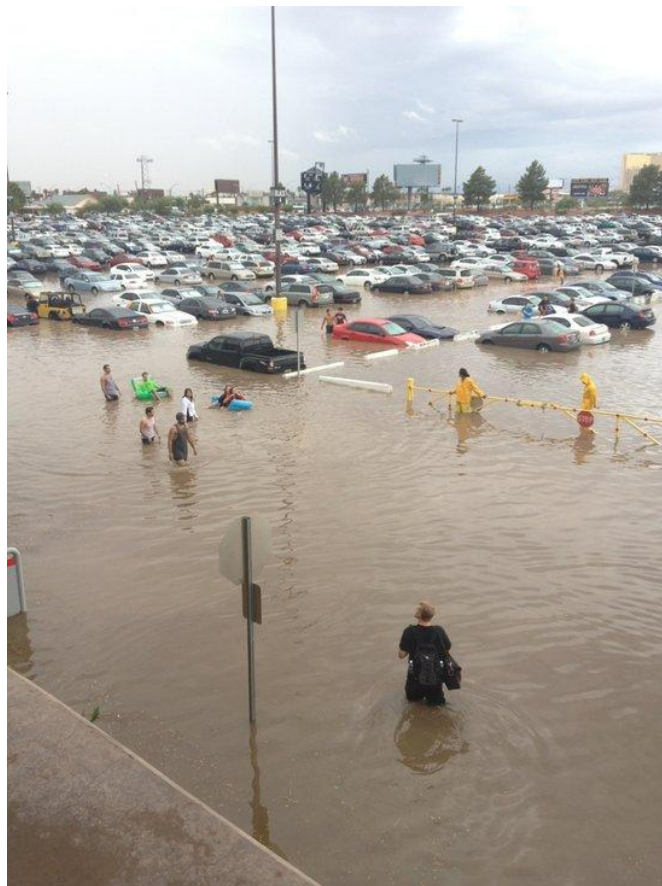
Flooding in the parking lot of UNLV. Photo courtesy: KLAS-TV/Las Vegas.

Flooding was also extensive on the campus of the University of Nevada Las Vegas. Floodwaters entered the TBE Building and also flooded portions of a parking lot south of the Thomas and Mack Center where at least two dozen cars were submerged. Floodwaters also entered a nearby shopping center on Maryland Parkway damaging 10 businesses. Some businesses reported a total loss with damage to furniture and equipment. Water also entered the MGM Grand Garden Arena with about two inches of water collecting in some areas.
